ACO SPORT

Oro Valley Aquatic Center
Oro Valley, AZ

PROJECT PORTFOLIO

System 4000 with gray plastic ADA grates

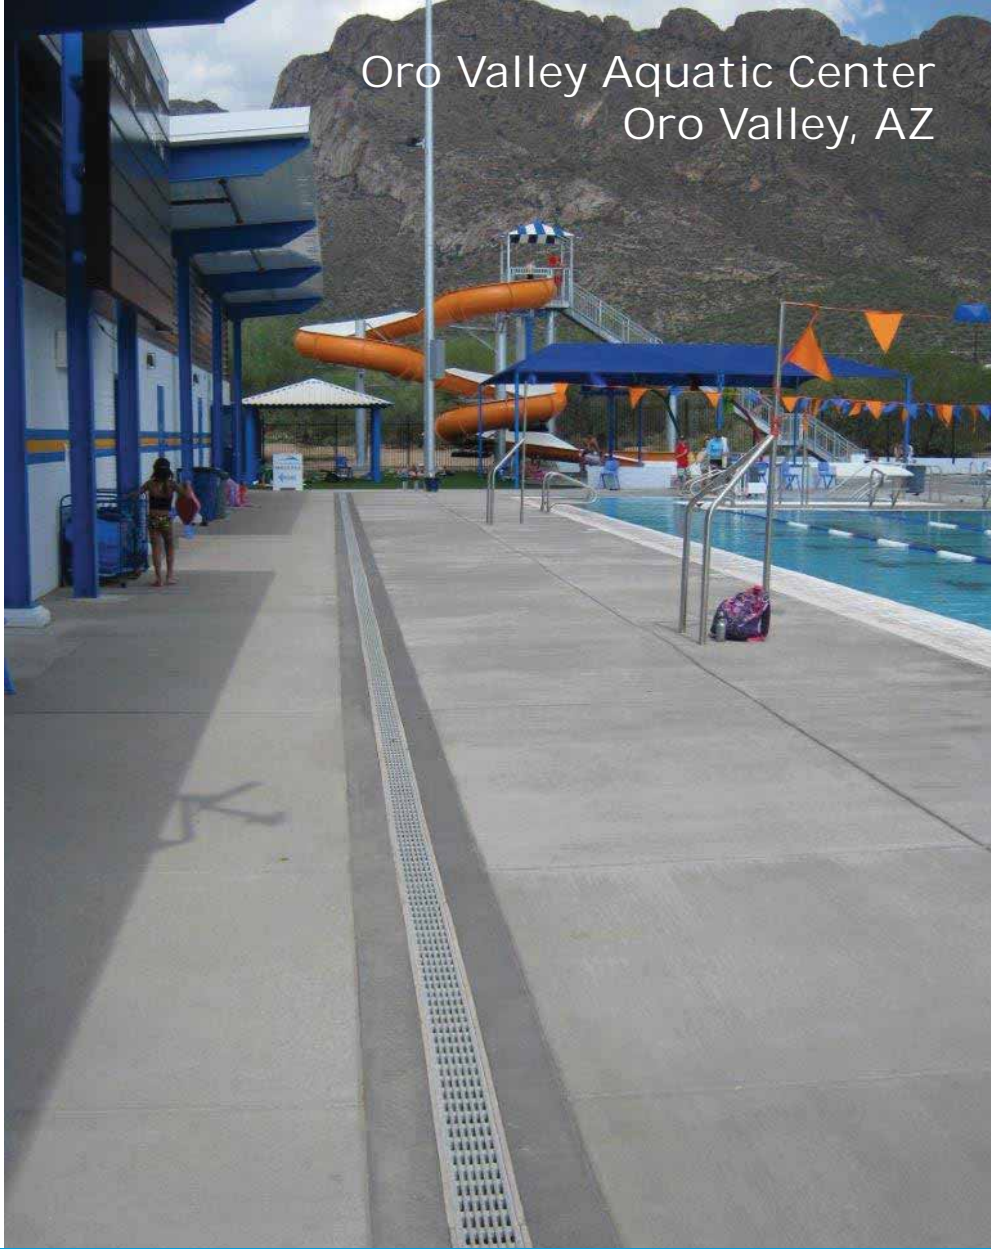
swim meets. As part of this deck upgrade a trench drain was required around almost the entire pool.

System 4000 with type 495 gray plastic grates was chosen. The polymer concrete edge and plastic grate are resistant to most chemicals, do not heat up excessively in the Arizona heat and are barefoot friendly with no sharp edges.
